RAA Highway Assessment

Highway One

August 2013

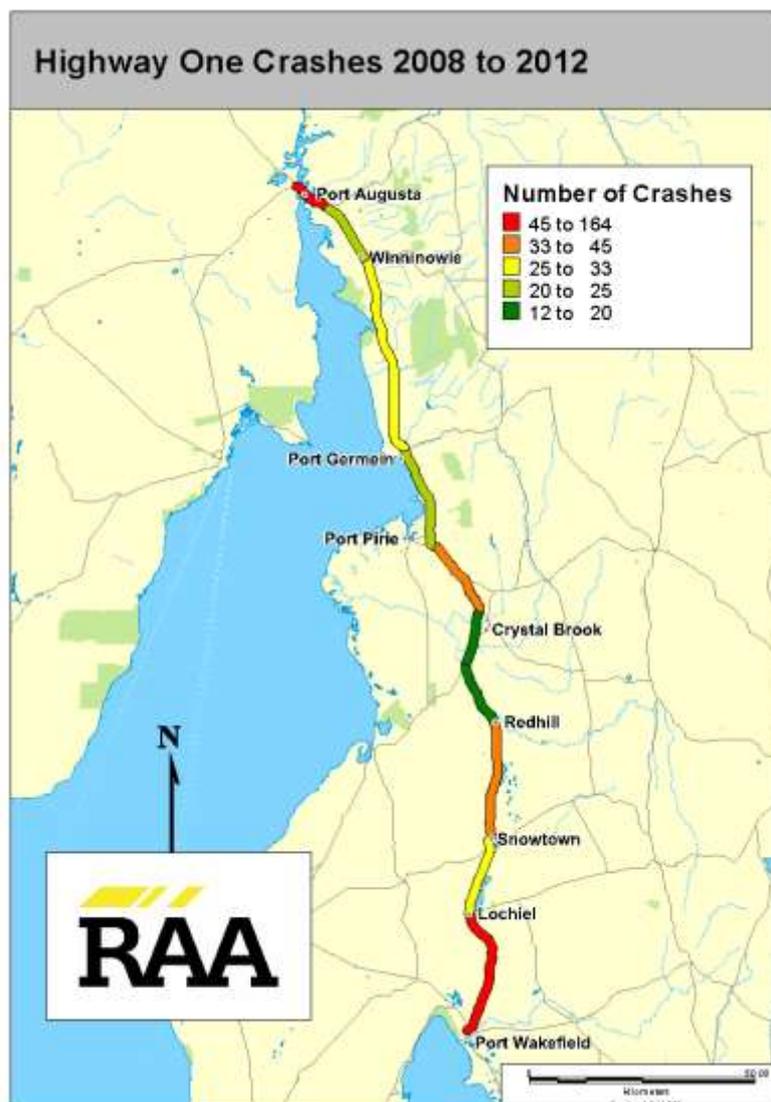
Figure 1 – Crashes Along Highway One, 2008-2012

Crash totals tend to vary along different sections of the Augusta Highway with a high frequency of crashes occurring on approach to Port Augusta as well as between Port Wakefield and Lochiel.

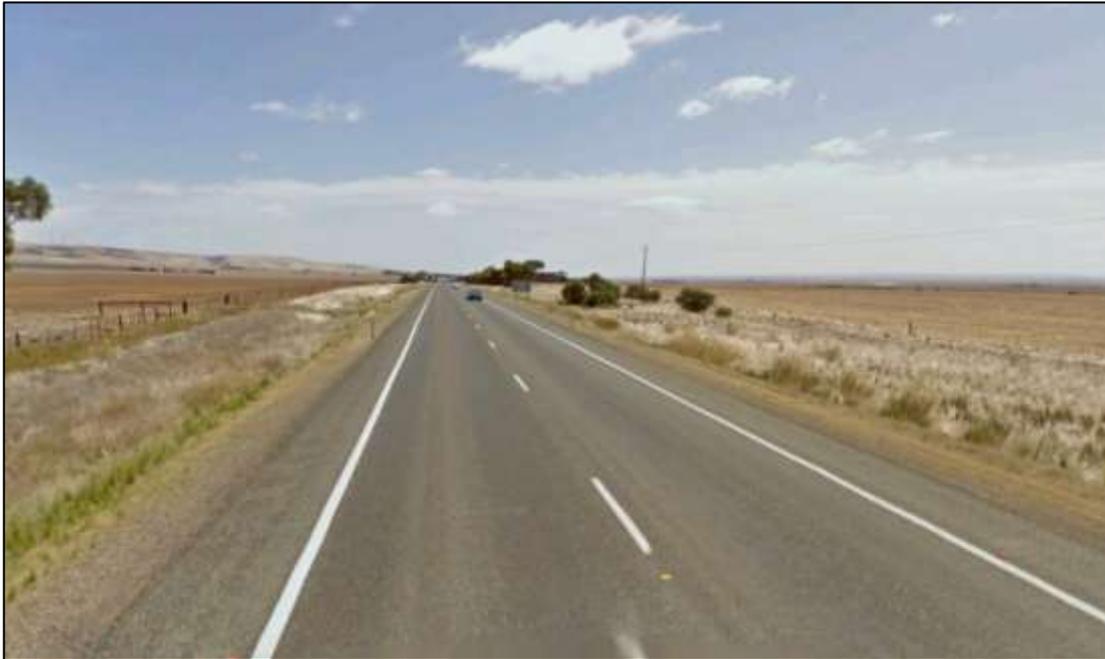
Figure 4 - A typical section of Highway One with driving lane of approximately 3.6 metres and sealed shoulders of approximately 1.3 metres, 5 km North of Snowtown (Google Street View 2010)

Like the width of the driving lanes, the sealed shoulders were also found to be acceptable. Increasing the width of the sealed shoulder should however be considered if heavy freight movements continue to increase in the area as a result of the mining expansion, to provide a larger safety buffer for the heavy vehicles.

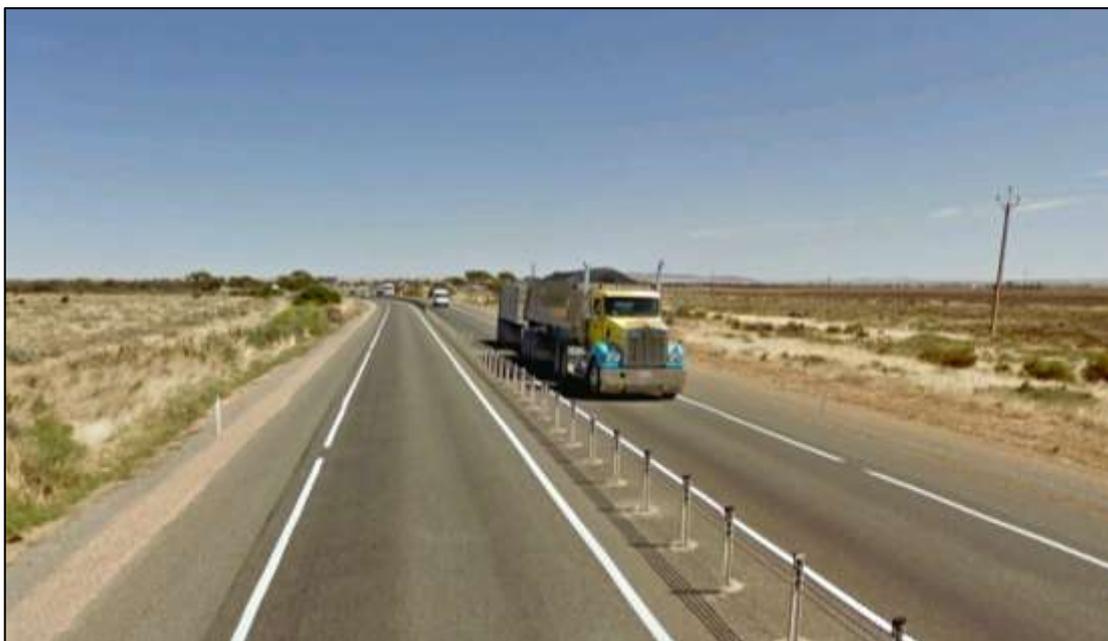
Figure 5 - Separating Median barrier fencing, used to prevent head-on collisions due to driver fatigue, however could be also be implemented to prevent overtaking in high risk areas (Google Street View 2010)

The best solution to eliminate the risk of head-on collisions from overtaking is full duplication of the section of highway between Pt. Wakefield and Pt. Augusta to provide two lanes of traffic in each direction. While this has the highest cost, in the long term, it is the only solution that will significantly improve the efficiency of South Australia's busiest highway, while eliminating the risk of head-on collisions.

Other options include further construction of overtaking lanes for other sections of the highway or installing median barriers to prevent motorists from overtaking in areas which have been identified as high risk.

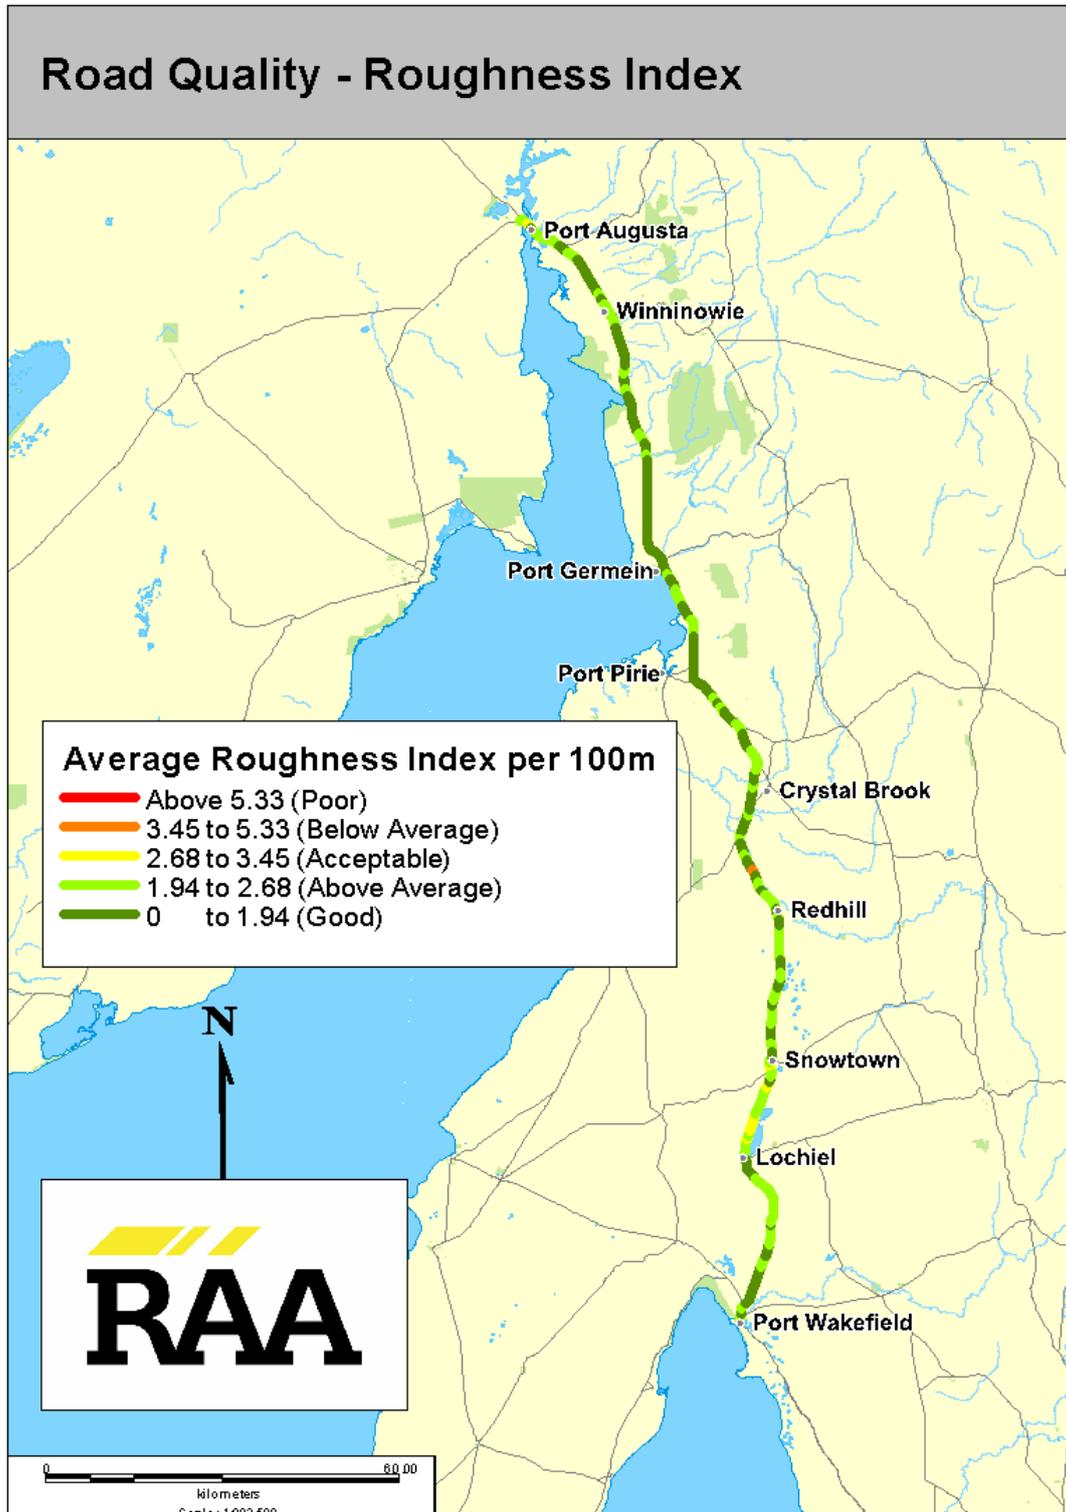
Figure 6 – Ride Quality Map for Highway One

The ride quality along Highway One is above average or good indicating a very smooth ride with few undulations for most of the highway. There is a very short section between Rehill and Crystalbrook that is below average but given the length of the section, pavement rehabilitation should be reasonably low cost and quick to apply. RAA welcomes the standard of ride quality on Highway One and hopes to see this standard applied across the other highways in SA.

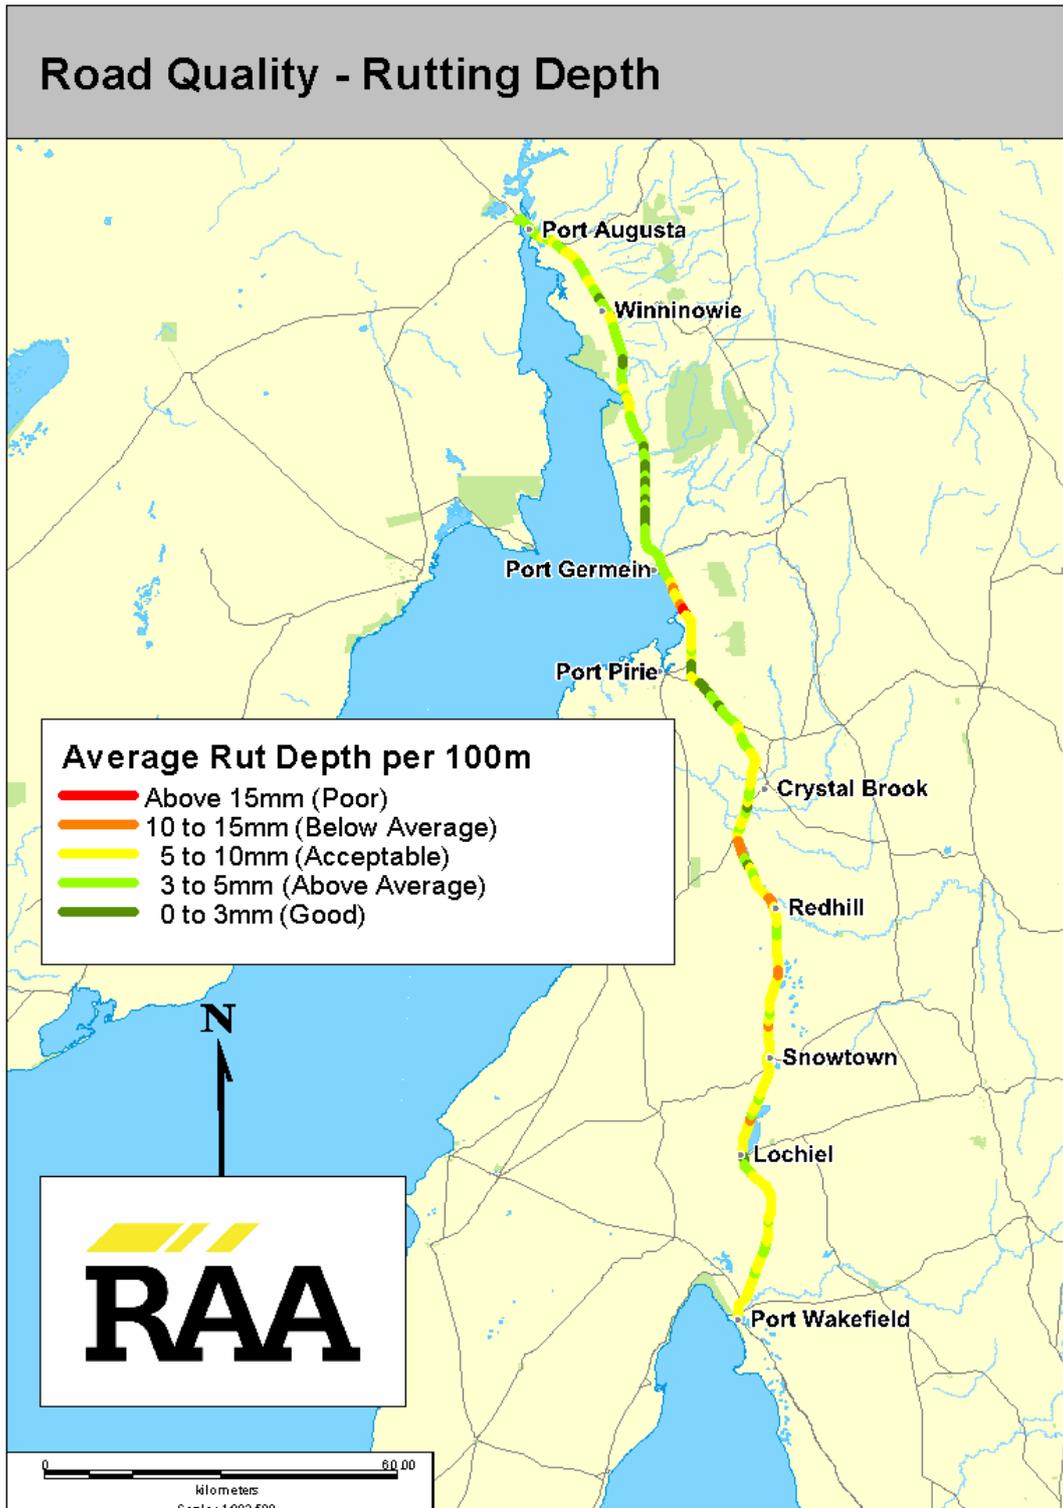
Figure 7 – Rutting Map for Highway One

Towards 2020 has identified rutting as the major surface quality issue on Highway One, with most of the highway suffering from some level of rutting. The area of road 5 – 10 km South of Pt. Pirie was identified as being of particularly poor quality at the time of Towards 2020.

Rutting is the channelling of the road under both wheel paths which occurs over time due to high volumes of heavy vehicles. Rutting is dangerous as it can trap rainwater, which can cause aquaplaning and result in a loss of control of the vehicle. Severe cases of rutting can also act as “guide rails” to the tyres, reducing steering performance and causing issues for tracking of trailers.

Some improvements have been made to the highway since Towards 2020 through maintenance and upgrade works. AusRAP has described approximately 174 km of the highway as being in “good” condition, approximately 17 km as “Medium” condition, and approximately 8 km as “poor” condition. The pavement data recorded shows that rutting is within acceptable limits of 5 to 10mm for most of the highway. North of Port Germein, rut depths were shallow and considered above average or good. Nevertheless, there are a number of short sections south of Port Germein that had rut depths of between 10 and 15mm which is below average. Of particular concern is a section midway between Port Germein and Port Pirie with ruts above 15mm in depth recorded. This is a poor standard and should be rectified as a matter of urgency. Since this level of rutting occurs over a relatively short section, RAA would expect that pavement rehabilitation on this section would be achievable within the next 12 months.

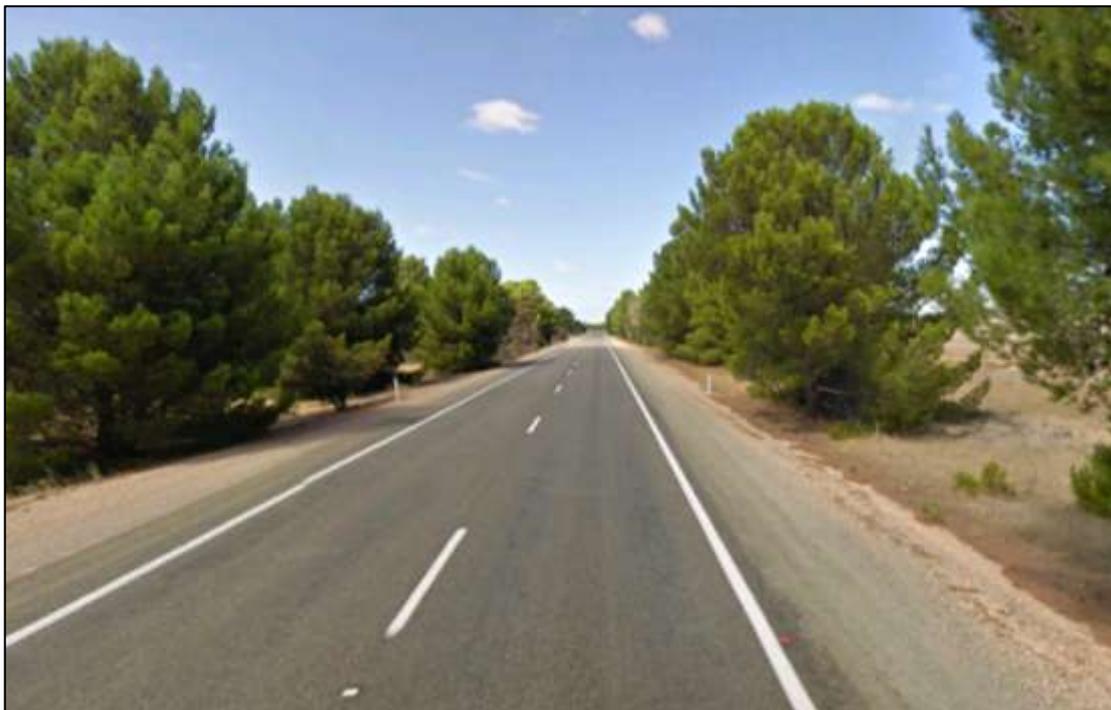
Vegetation levels on Highway One vary throughout the length of the road from sparse, to areas of dense trees. AusRAP data shows that approximately 45 km of the highway are lined with trees of a diameter greater than 10 cm, and the remaining 155 km has no significant vegetation recorded near the edge of the road.

Figure 8 - An example of significant vegetation on Highway One, approximately 10 km South of Snowtown (Google Street View 2010)

Since collisions with fixed objects account for the highest number of crashes on rural highways in South Australia, it is important to consider protecting these hazards, or removing the hazards such as trees and vegetation completely. As it would be both impractical and uneconomical to construct safety barrier fencing to protect the entire 45km section of roadside hazards, further research should be undertaken to prioritise the locations at which the barriers are provided.
