# **RAA Highway Assessment**

Riddoch Highway

**June 2013**

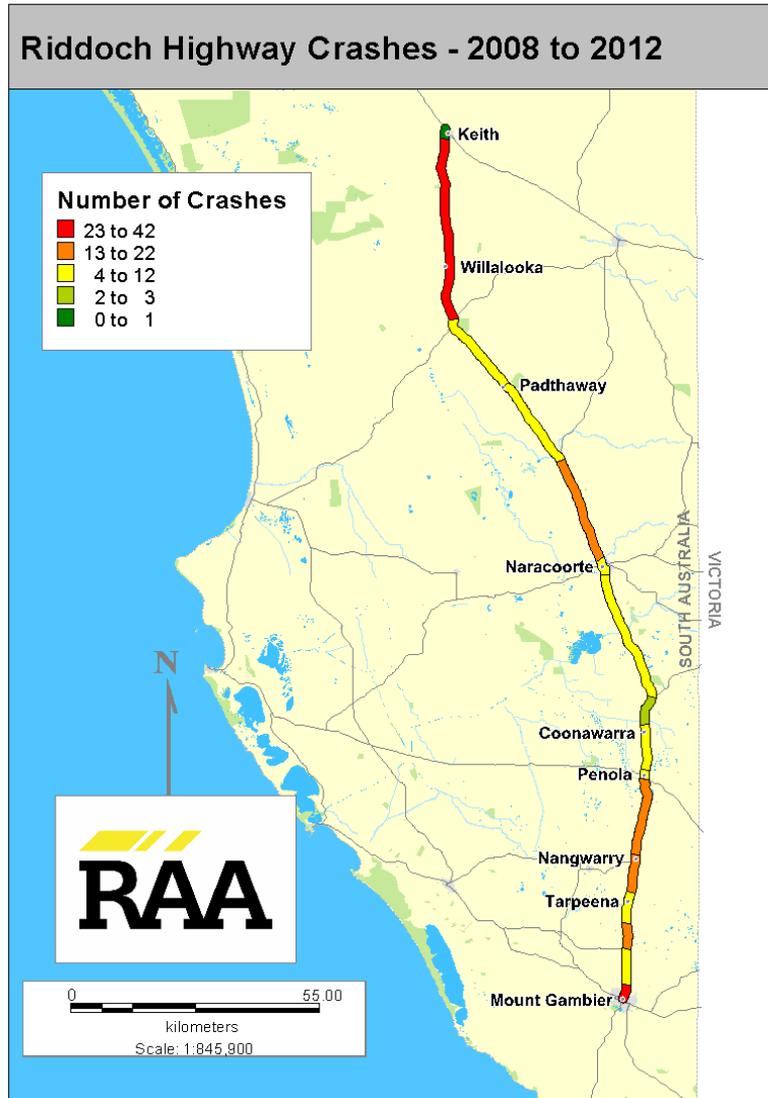
Figure 1 – Crashes Along Riddoch Highway, 2008-2012

Crash totals tend to vary along different sections of the Riddoch Highway, but the highest frequency of crashes occur between Keith and Willalooka, Keppoch to Naracoorte, Penola to Nangwarry and on the approach to Mount Gambier.

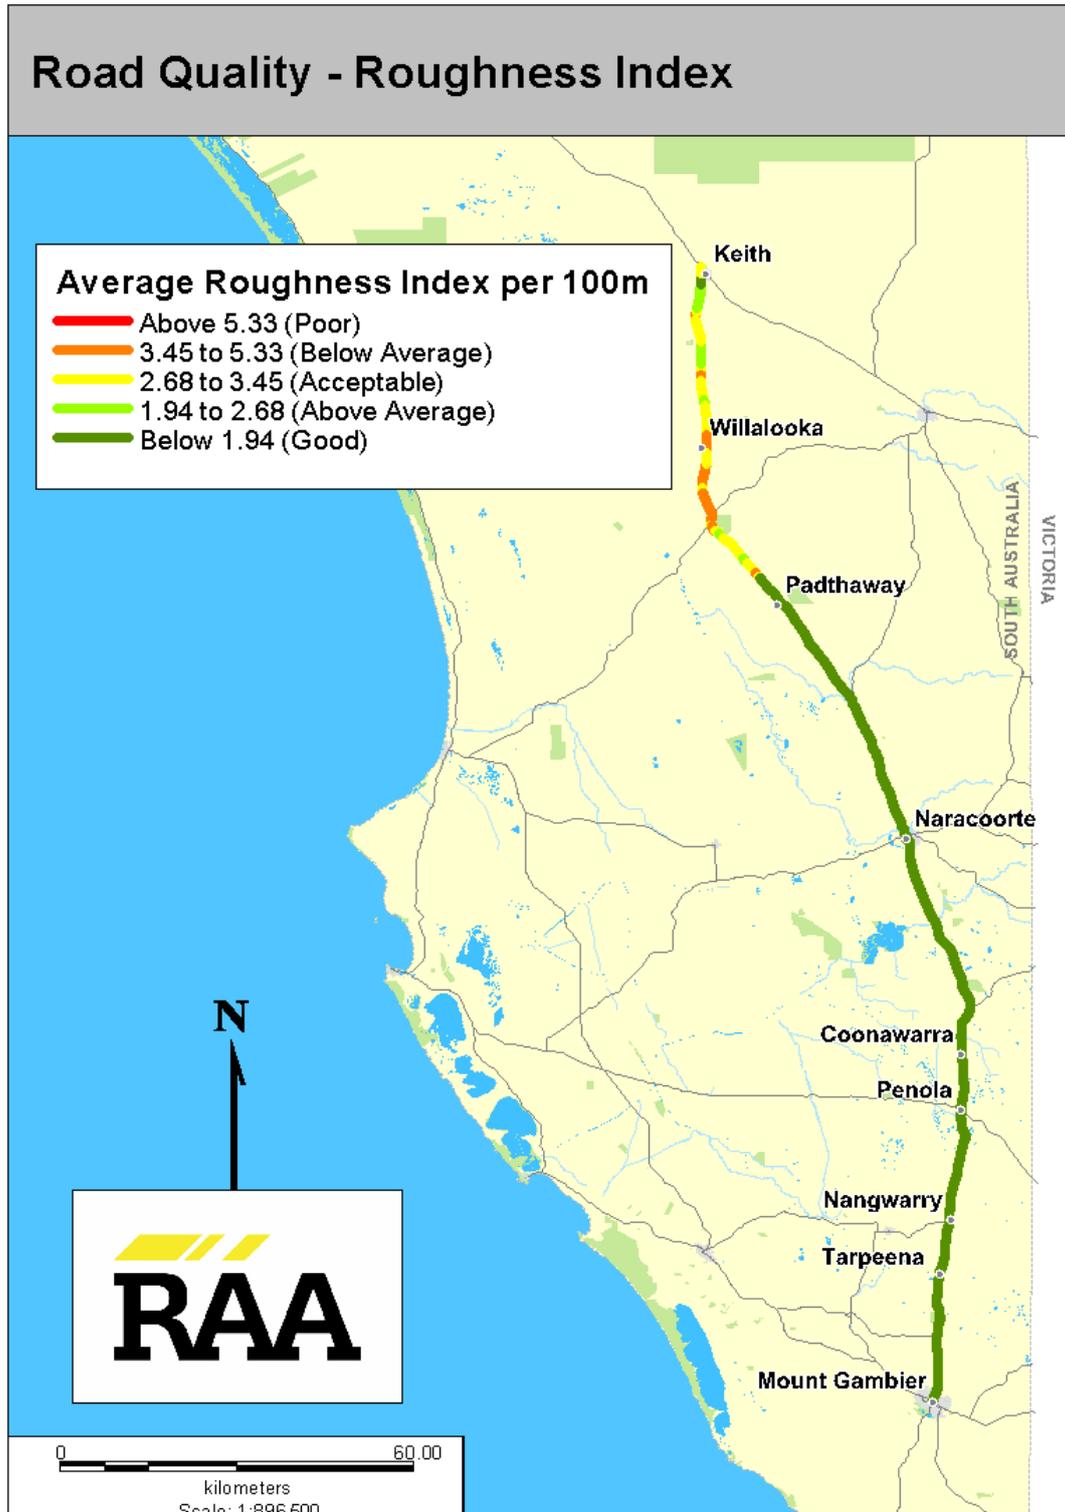
Figure 4 - Ride Quality Map for Riddoch Highway

A pavement survey of Riddoch Highway (Figure 4) shows that the ride quality is acceptable (IRI between 2.69 to 3.45) between Keith and Willalooka. South of Willalooka, the ride quality is generally below average (IRI 3.46 to 5.33) and drivers are likely to experience many undulations with some level of discomfort. From Padthaway to Mount Gambier, the pavement survey shows that the ride quality is very good (IRI less than 1.94) and is at a level that is comparative to a newly constructed road. While overall the ride quality on Riddoch Highway is very good, further work is required as part of the ongoing maintenance program, to improve the ride quality at the poorer sections identified above.

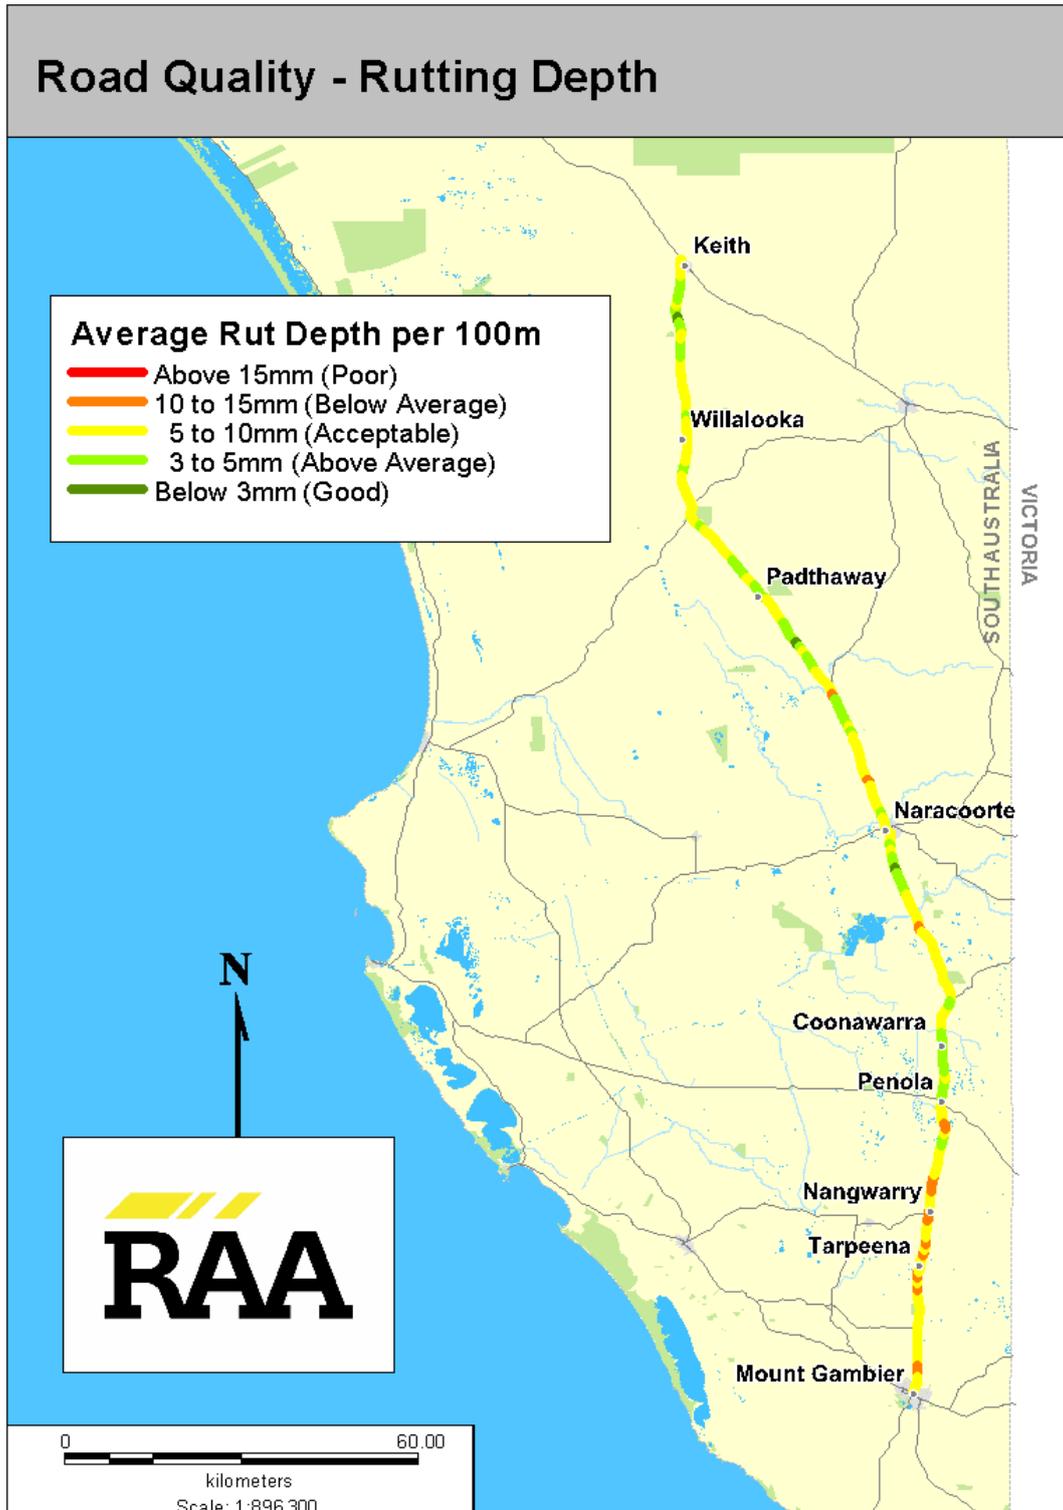
Figure 5 – Rutting Map for Riddoch Highway

For the majority of the route, pavement rutting is less than 10mm which is acceptable. There are a few exceptions highlighted in the top section of the highway in Figure 5. The most notable instances of rutting defects appear to be concentrated between Penola and just south of Tarpeena, where several sections of the route show rut depths of between 10mm to 15mm which is below average. These sections attract a higher risk of aquaplaning and the potential to reduce steering performance. In September 2012, DPTI filled ruts along a 2km section in this area but while this is a step forward, significant pavement rehabilitation is still required to reduce rutting in this region of Riddoch Highway.

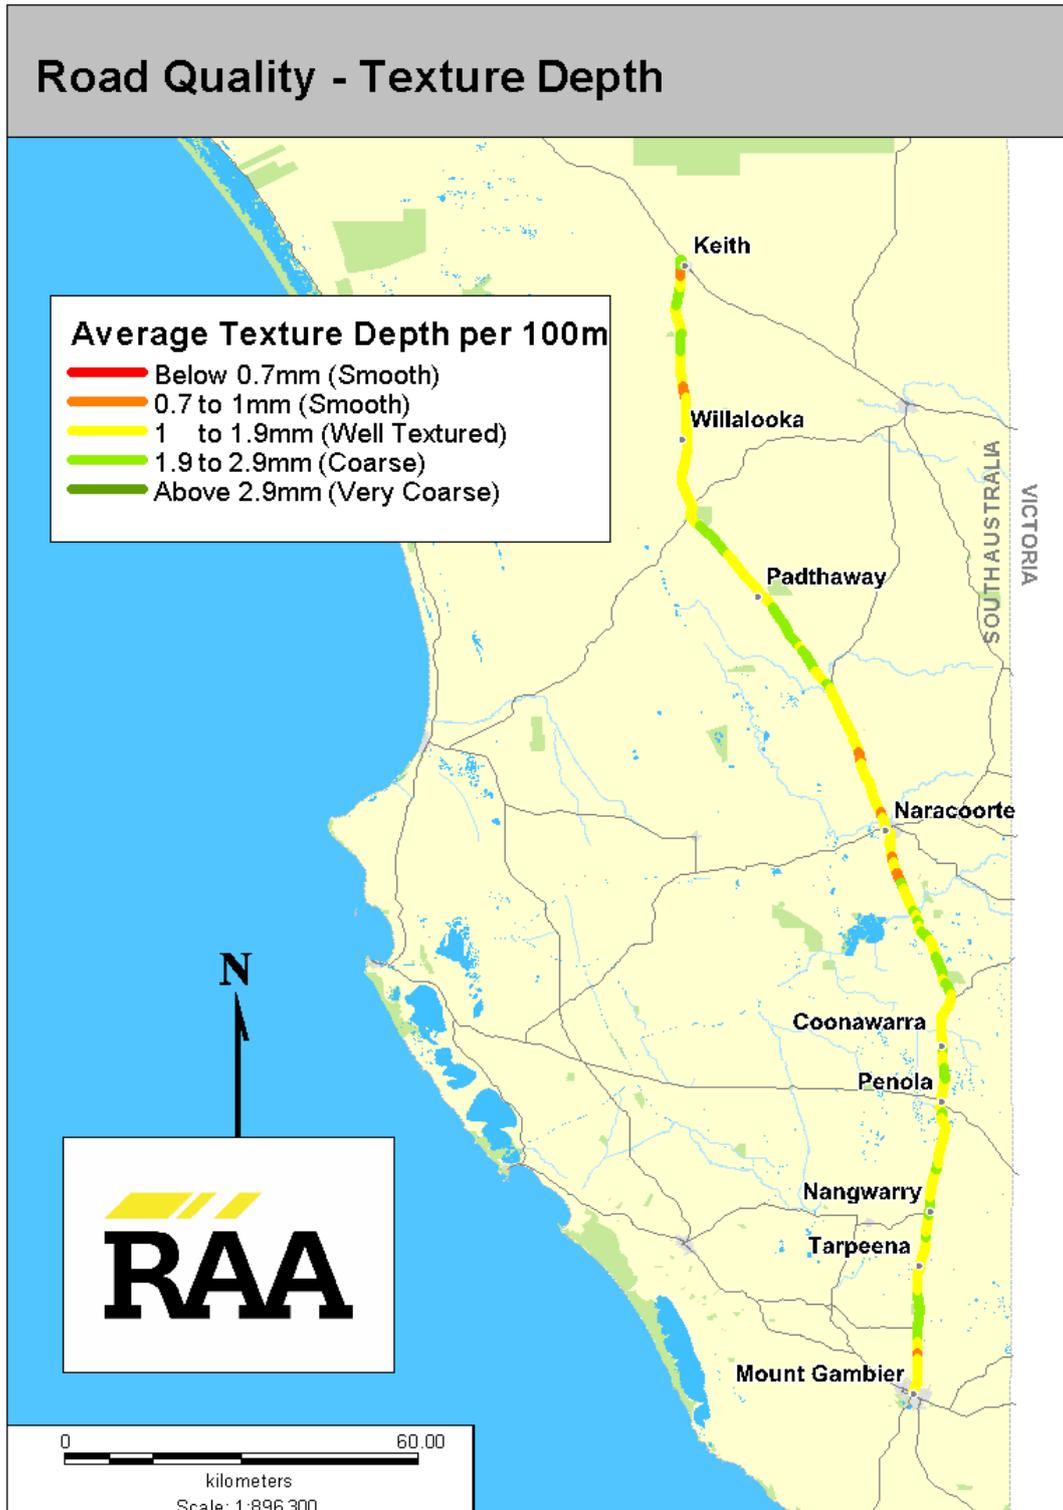
Figure 6 – Texture Map for Riddoch Highway

The pavement survey results for texture depth measurements are shown in Figure 6. With the exception of some areas, the texture is between 1.1mm and 1.89mm for most of the route representing a well textured surface. Areas of concern are the minor sections immediately south of Keith and just north of Willalooka, as well as various sections around Naracoorte. The texture at these locations was found to be smooth with depths ranging between 0.7mm and 1mm. This results in a high risk of vehicles leaving the road and drivers may experience poor braking action due to insufficient friction between the tyre and pavement surface. The texture does not allow for adequate drainage of water, increasing the risk of aquaplaning. Remedial works to provide better surface texture at the locations identified should be undertaken as a matter of urgency.
