RAA Highway Assessment

Sturt Highway

August 2013

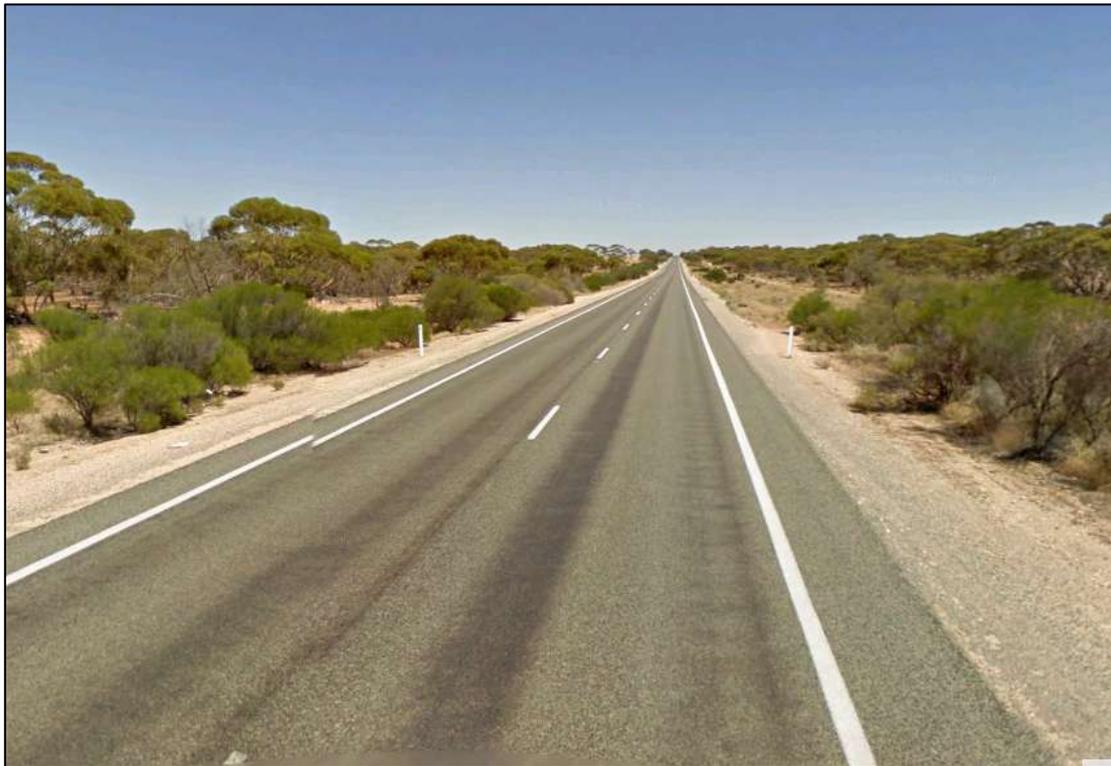
Figure 4 - A typical section of the Sturt Highway with sealed shoulders of approximately 1 metre (Google Street View 2010)

Sealed shoulders on the Sturt Highway are less than 1 metre for approximately 140 km, between 1 metre and 2.4 metres for approximately 60 km, and wider than 2.4 metres for approximately 5 km.

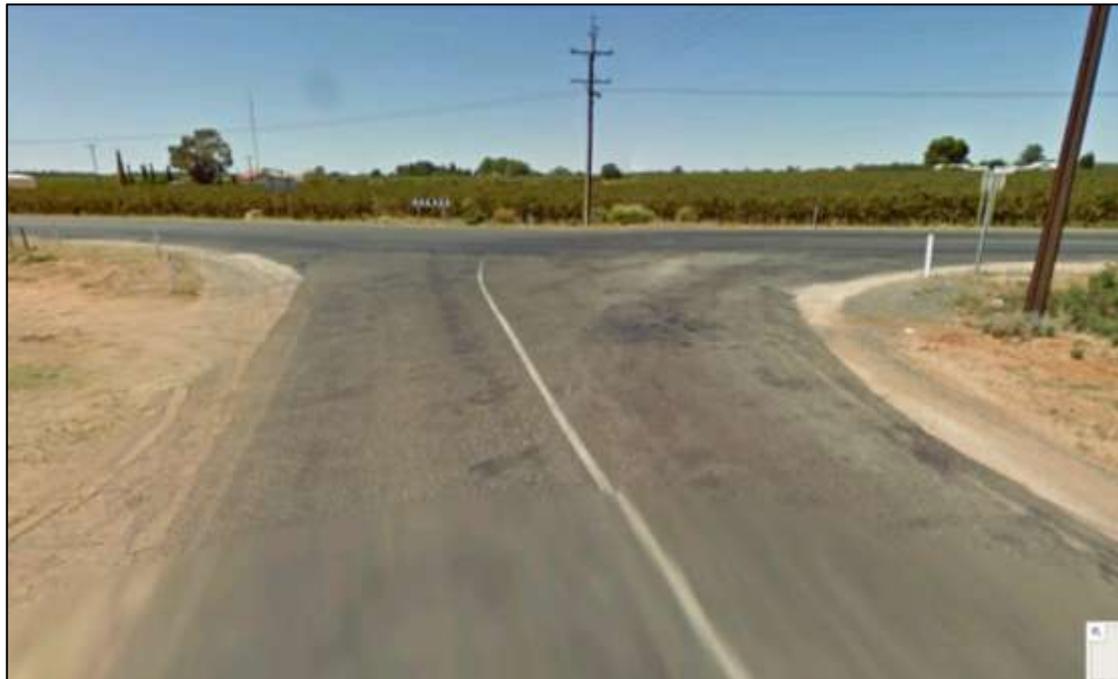
Figure 5 Intersection with Germein Road. Uncontrolled with no prior warning for drivers on the terminating road (Google Street View 2012)

Figure 5 shows the intersection of Sturt Highway and Germein Road. Drivers might misjudge this intersection as there is no clear stop or give way line and the geometry may make turning into heavy traffic flows difficult. Improvements to an intersection such as this should include advanced warning of the upcoming intersection for drivers on Germein Road, give way signs and lines to help drivers position their vehicles, and filter lanes in and out of the intersection to allow vehicles to accelerate and merge into traffic on the Sturt Highway.

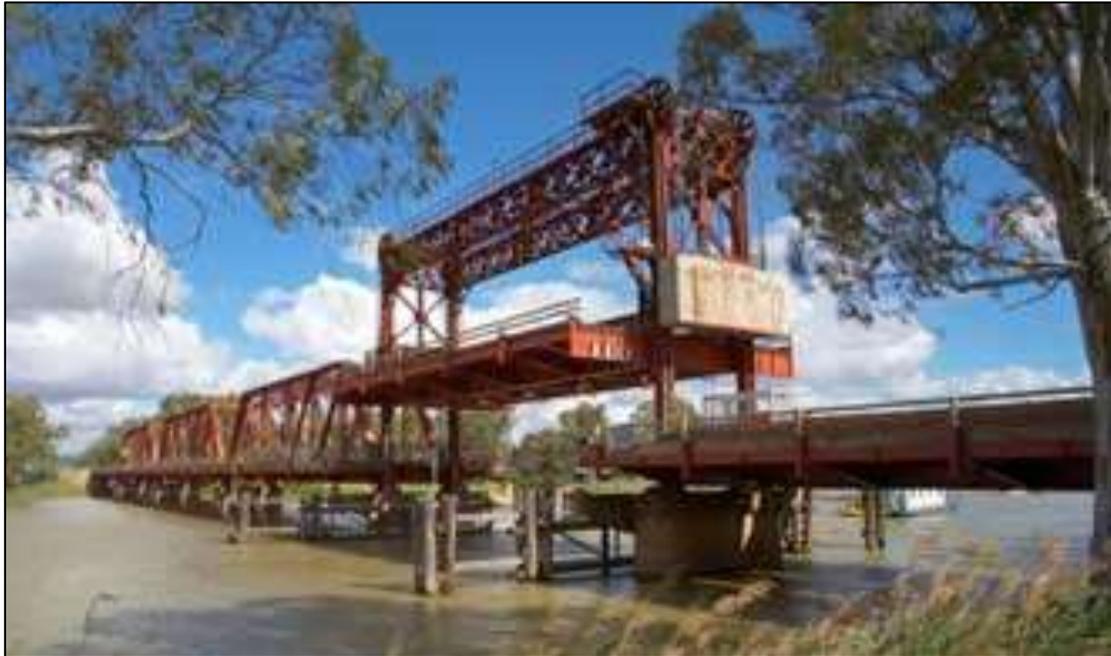
As the bridge was designed for use in the 1920's it is incapable of providing efficient traffic flow given the high traffic volumes that the Sturt Highway currently carries. Speed restrictions for the bridge are 30 km/h, and entrance to the bridge is controlled by traffic signals, directing motorists to stop when the bridge is opened for boats to pass through. The driving lane along the bridge is approximately 3.2 metres wide, leaving little room for error when large commercial trucks are passing through.

Figure 6 - The Paringa Bridge open for boats to pass through (Google Image)

If traffic volumes continue to increase on the Sturt Highway, along with the movement of heavy freight vehicles through the area, the Paringa Bridge will require significant upgrades or a new bridge will be required. As the Sturt Highway is a major freight route, it is neither efficient nor acceptable to have a bridge subject to a 30km/h speed restriction and which stops traffic twice daily as the only crossing over the Murray River.

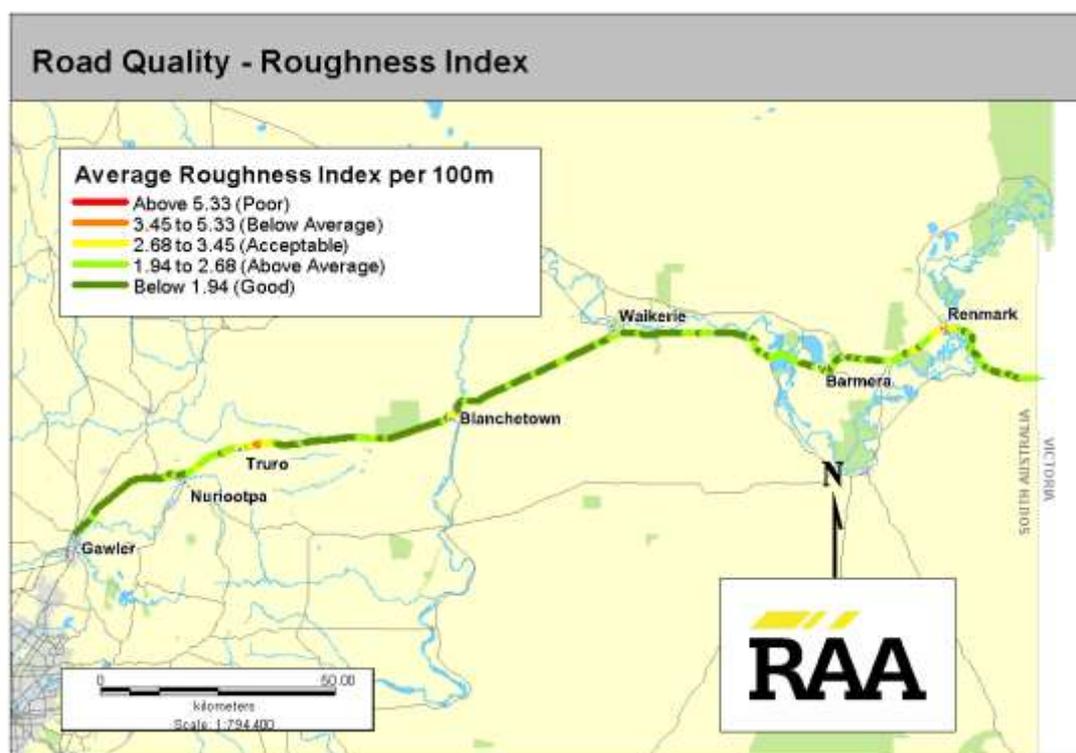
Figure 8 – Ride Quality Map for Sturt Highway

Towards 2020 identifies roughness and rutting as the main pavement concerns on the Sturt Highway. The ride quality results of the pavement survey are shown in Figure 8 and show that for almost the entire length of the highway, the ride quality is above average or good. This was reflected in RAA's highway review which did not identify any significant areas of roughness or rutting. The quality of the pavement was considered good and offered a smooth and even ride to motorists. This may be due to upgrade works which have improved the surface quality since the time of *Towards 2020*. AusRAP data for the Sturt Highway also confirms RAA's observations, showing that approximately 190 km of the highway is in "good" condition, approximately 8 km is of "medium" condition, and approximately 3 km is of "poor" condition. It is important that areas of poor and medium condition such as to the east of Truro be targeted as a priority for upgrade and maintenance work.

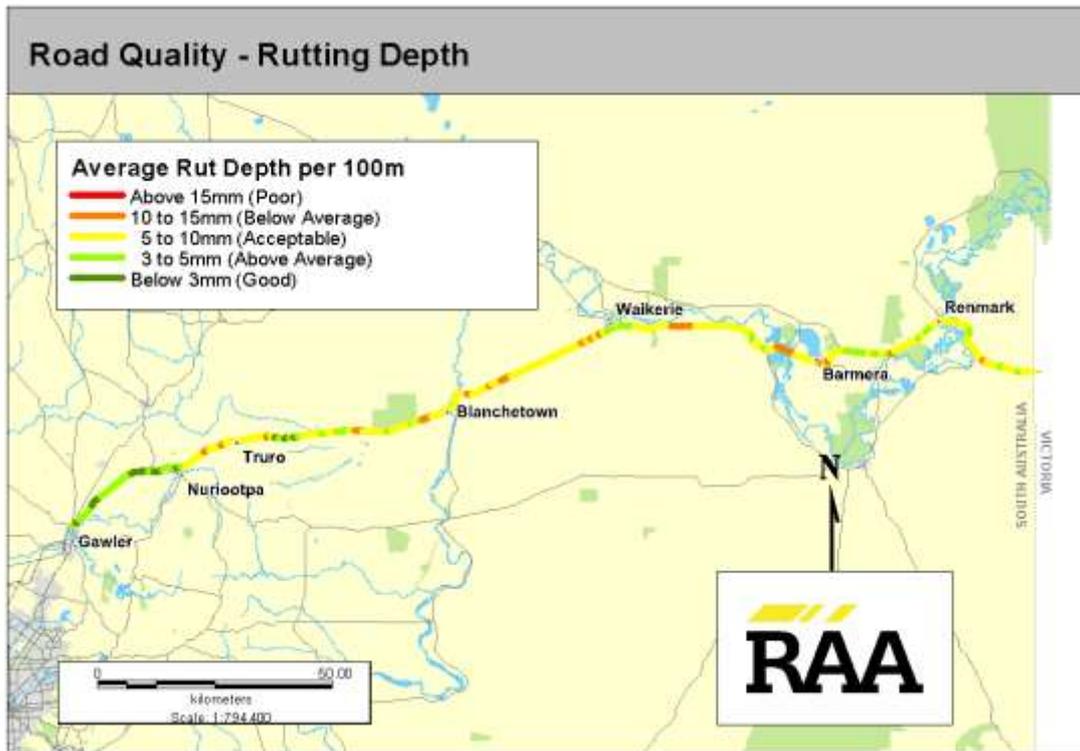
10mm deep which is considered acceptable. There were however a number of sections with rut depths of between 10 and 15mm which is below average and cause for concern as it is thought that the potential for aquaplaning can occur with rut depths greater than 10mm.

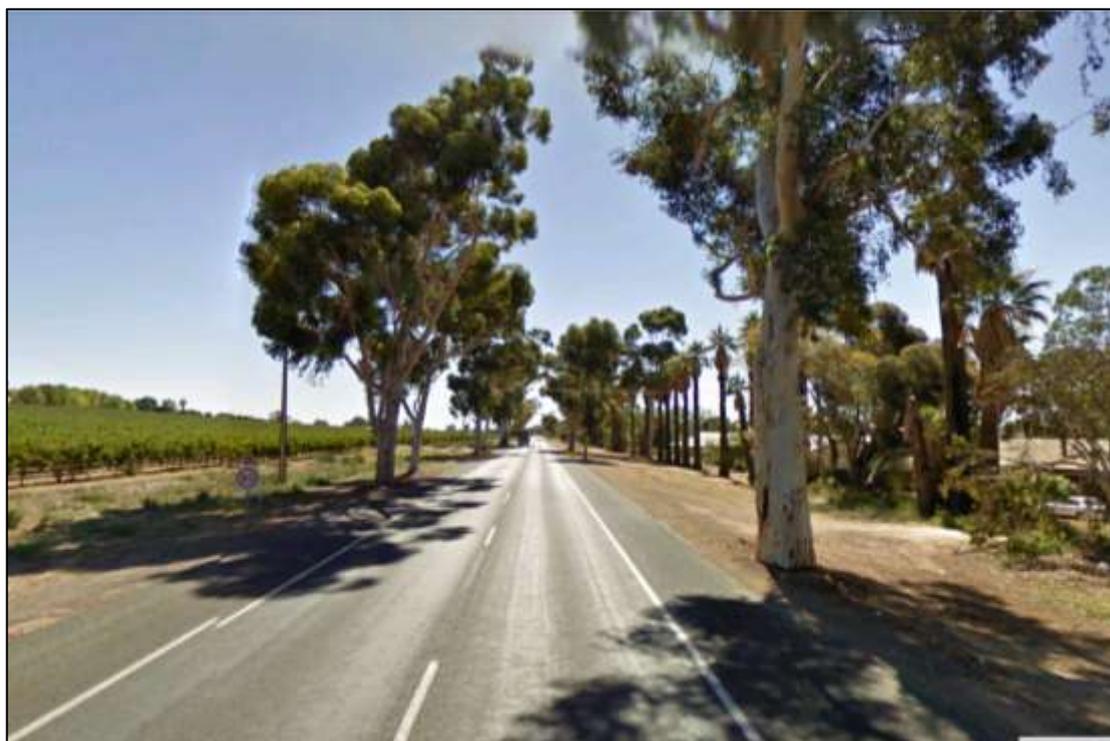
There are some areas of concern, such as the section just west of Barmera. In this area very large Gum Trees are only approximately 3 metres from the driving lane, as shown in Figure 10.

Figure 10 - Roadside hazards on the Sturt Highway (Google Street View 2010)

AusRAP data shows that there is approximately 15 km of rigid safety barrier, and 5 km of wire rope safety barrier already offering protection from hazards on the Sturt Highway. While RAA welcome these measures, we wish to see protection provided for all significant hazards that are located within 10 metres of the shoulder.
