# **RAA Highway Assessment**

Dukes Highway

**June 2013**

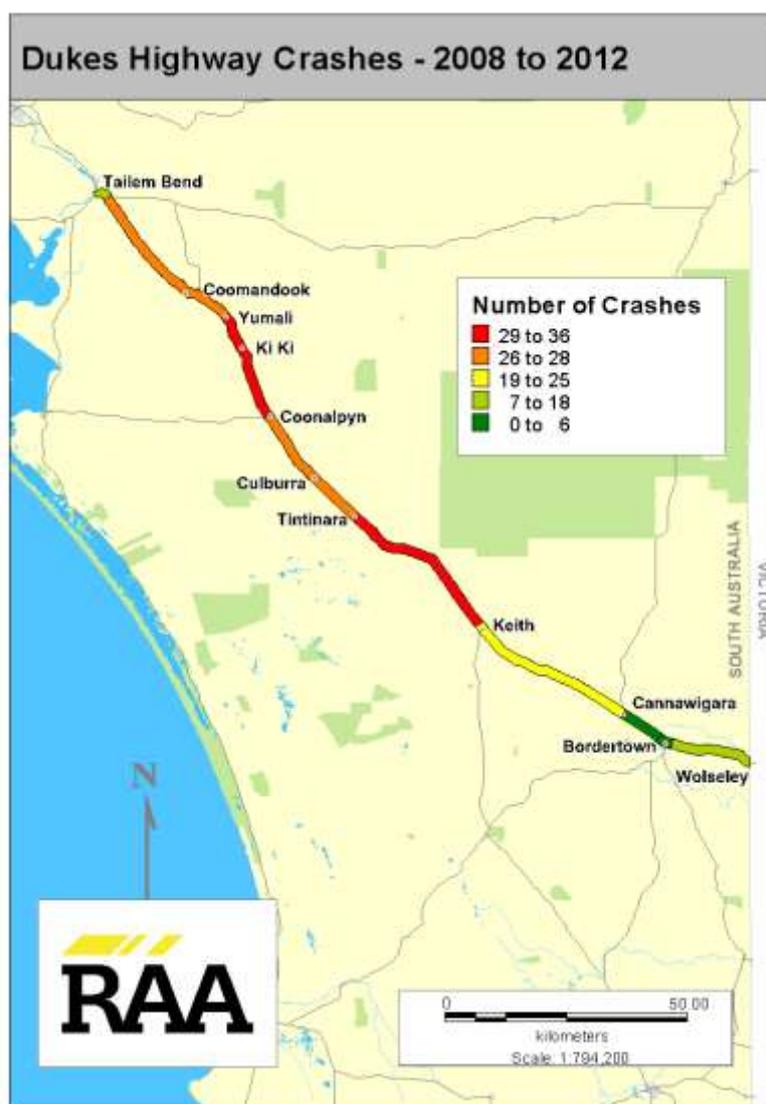
Figure 1 – Crashes Along Dukes Highway, 2008-2012

The following image illustrates the number of crashes by location along the Dukes Highway by section for the five year period, 2008 to 2012.

Crash totals tend to vary along different sections of the Dukes Highway, with crashes most numerous on the section between Tintinara and Keith.

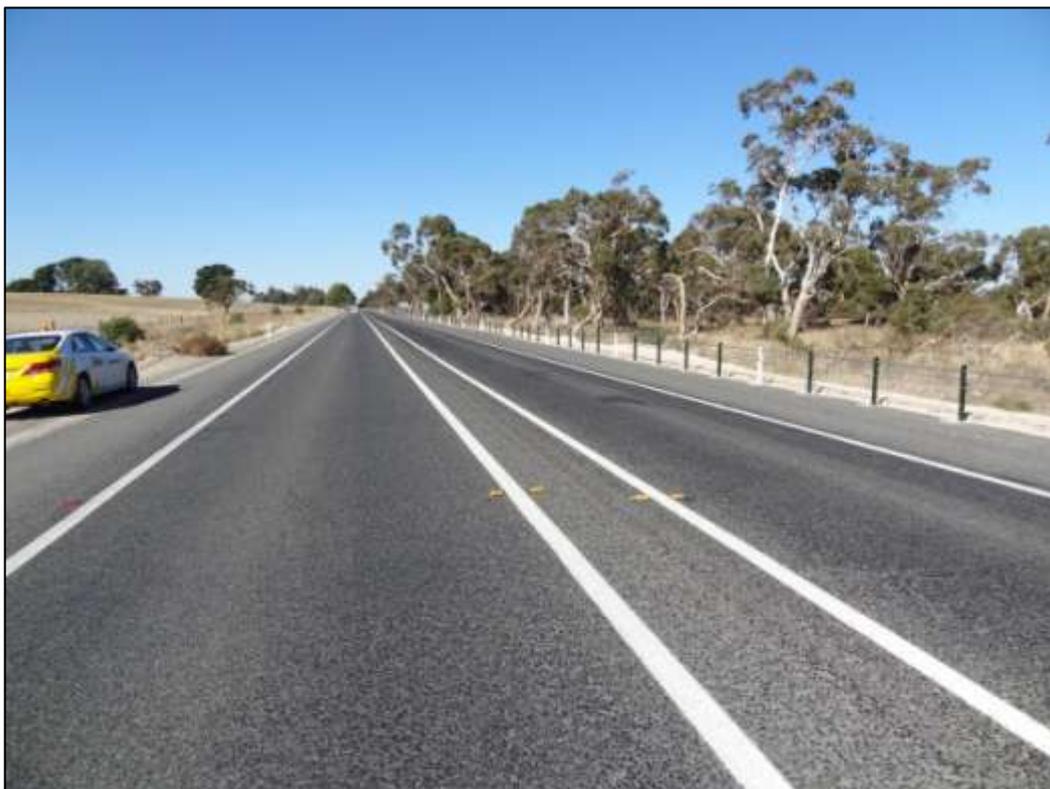
A wide centreline treatment has been a recent addition to the Dukes Highway in an attempt to reduce head on collision crashes in high fatigue areas. Wide centrelines provide motorists more time to correct an error should they drift from their traffic lane towards the lane of oncoming traffic. They are especially effective if used with Audio-Tactile Line Marking (ATLM). If a driver was to momentarily lose concentration and begin to drift, the noise and vibration caused by the ATLM should alert them and afford time to react before they enter the path of oncoming traffic or run off the road.

Figure 4 – Wide Centreline Treatment on the Dukes Highway

A wide centreline treatment is a good safety improvement to the Dukes Highway, and extending the length of the wide centrelines is encouraged and supported by RAA.

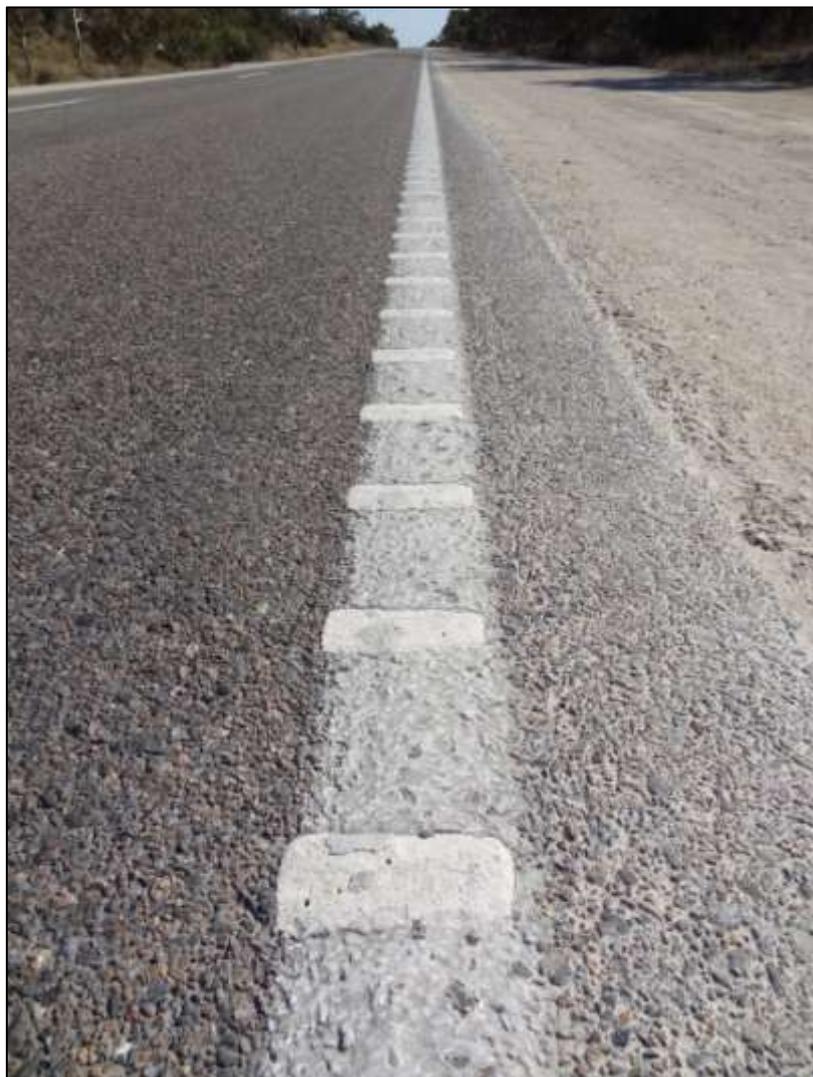
During the 2013 review of the Dukes Highway it was evident that much of the highway had ATLM on edge lines and even on centre lines at some locations. However it was also evident that in some locations the ATLM were beginning to wear away, and as such were losing effectiveness.

**Figure 5 – Worn Out Audio Tactile Line Markings on the Dukes Highway**

It was noted that these worn out ATLM do not produce the same noise and vibration as newer ATLM, therefore maintenance and upgrades should be considered to restore old and worn ATLM to improve the effectiveness of this safety strategy.

The RAA also recommend that further work is conducted to assess the useable life of this type of treatment.

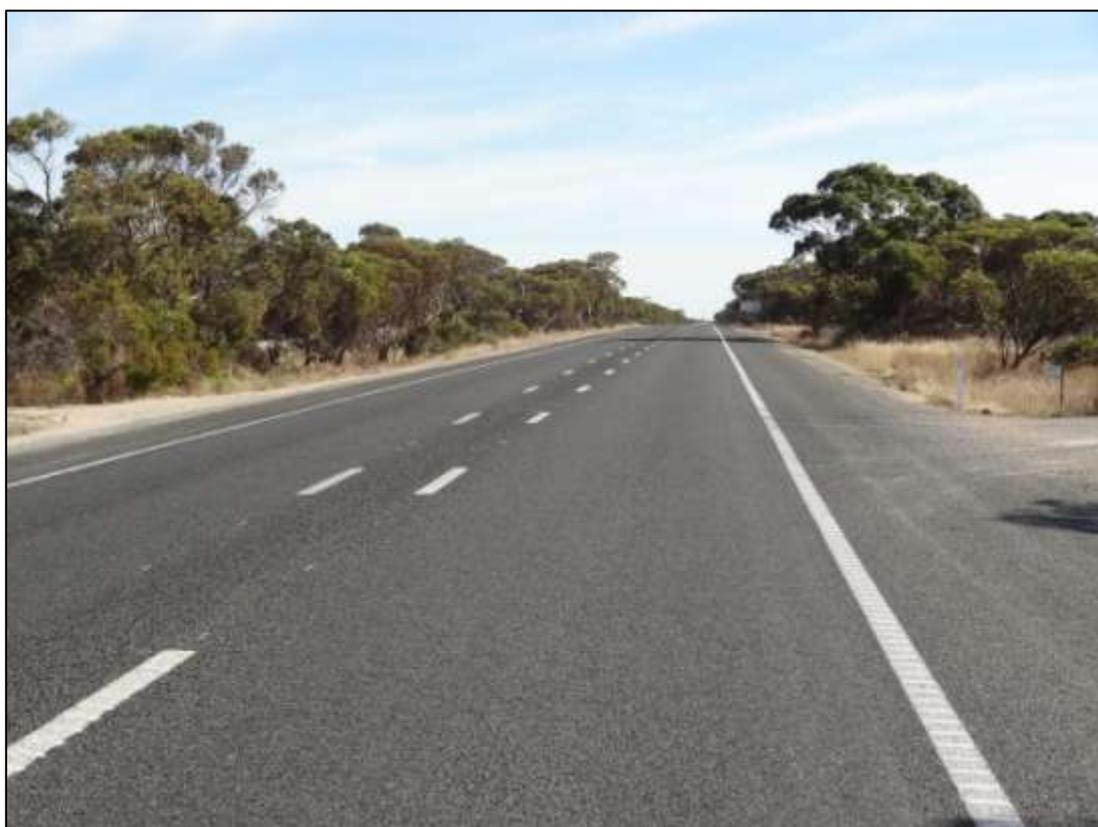
*Towards 2020* that the Dukes Highway provided a relatively smooth ride, with a low level of roughness when compared to other major South Australian Highways. This is supported by RAA's 2013 review, only minor roughness and undulations were noted just east of Ki Ki, and a section 5 – 10 km east of Bordertown. As the Dukes Highway is almost 200 km in length, only two instances of noticeable roughness is considered good. Furthermore, much of the highway was noted as having relatively smooth surface conditions, at least once every 10 – 15 km the highway was noted as having only minor undulations or a very smooth surface where the undulations were barely detectable.

Figure 6 – Good Pavement Conditions on the Dukes Highway

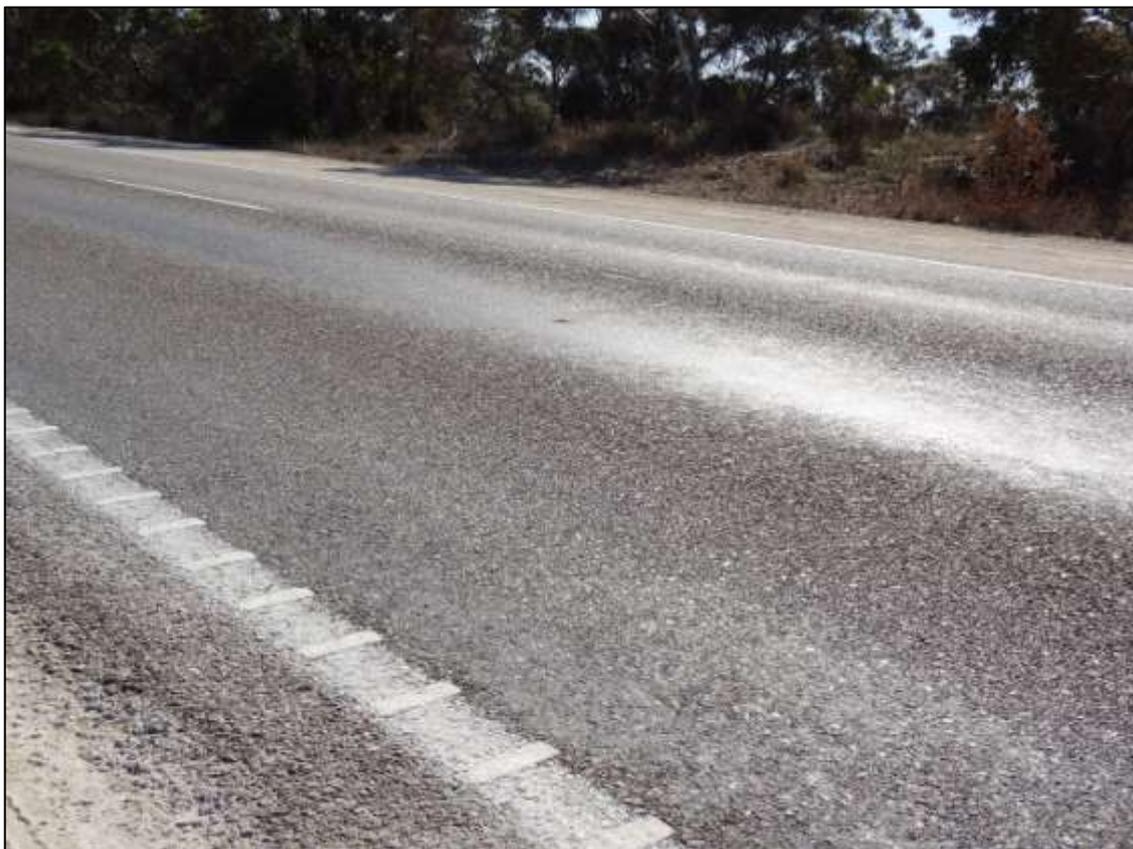
Along with rutting, surface aggregate loss was noted at many locations along the Dukes Highway, approximately once every 20km. Aggregate loss was only noted as severe at two locations; east of Coomandook and 5 km west of Coonalpyn.

Figure 9 – Severe Rutting and Signs of Aggregate Loss

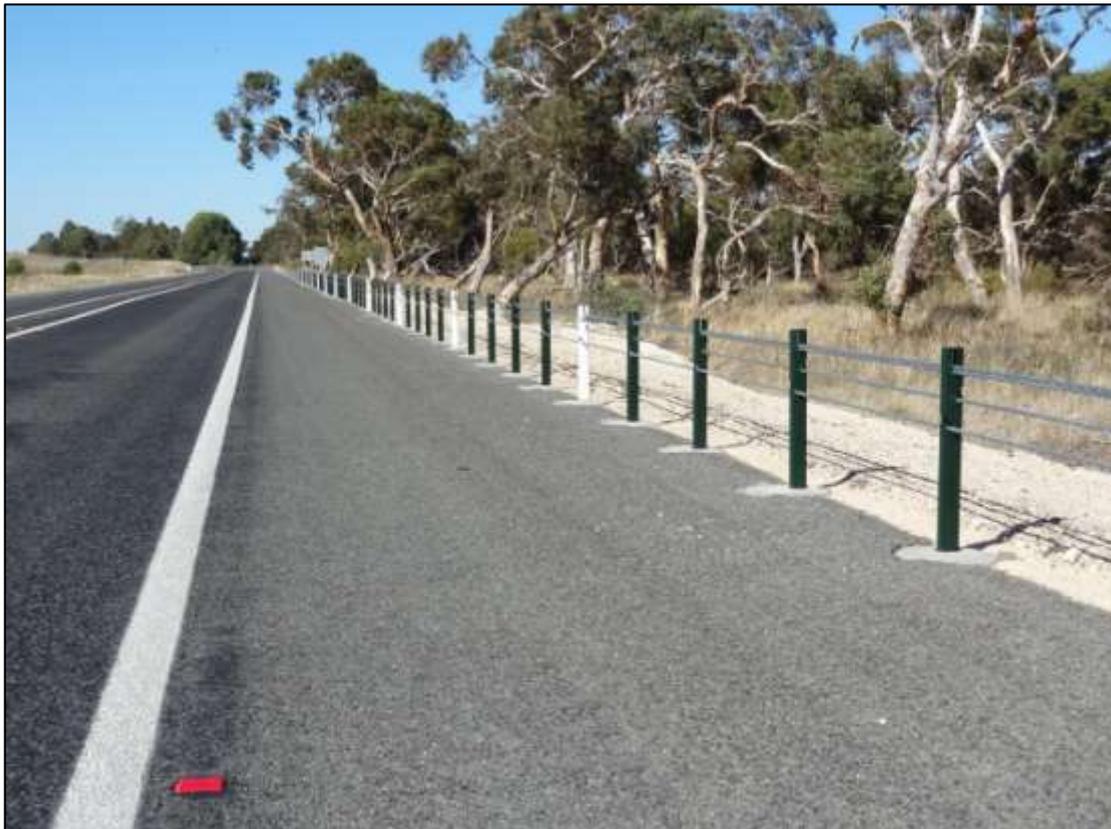
During the 2013 review of the Dukes Highway it was noted that the implementation of wire rope safety barriers is currently underway for many locations along the highway. There are long sections of road with wire rope barrier protection, particularly at the eastern end of the highway around Keith and Bordertown. Some sections of road have full edge protection for lengths of several kilometres.

Another issue identified with wire rope safety barriers is the close proximity of significant trees behind the barriers. Wire rope safety barriers are flexible, and therefore clear space is needed behind the barrier to allow for deflection. Wire rope safety barriers require a minimum of 3.14 metres for deflection (DPTI 2002), and it was noted on a few occasions during the 2013 highway review that significant trees were well within this distance and in some instances, were against the barrier. This poses a significant danger to motorists if a crash was to occur at these locations, as the barrier fence would provide minimal protection against the roadside hazard.

Figure 11 – New Wire Rope Barrier Fencing on the Dukes Highway

The installation of wire rope barrier fencing is a positive step towards reducing fatalities on the Dukes Highway however the placement of fencing appeared to be inconsistent. Some locations had hazard protection, while other locations with a similar hazard did not. This should continue to be monitored to enable planning of future barrier placement.

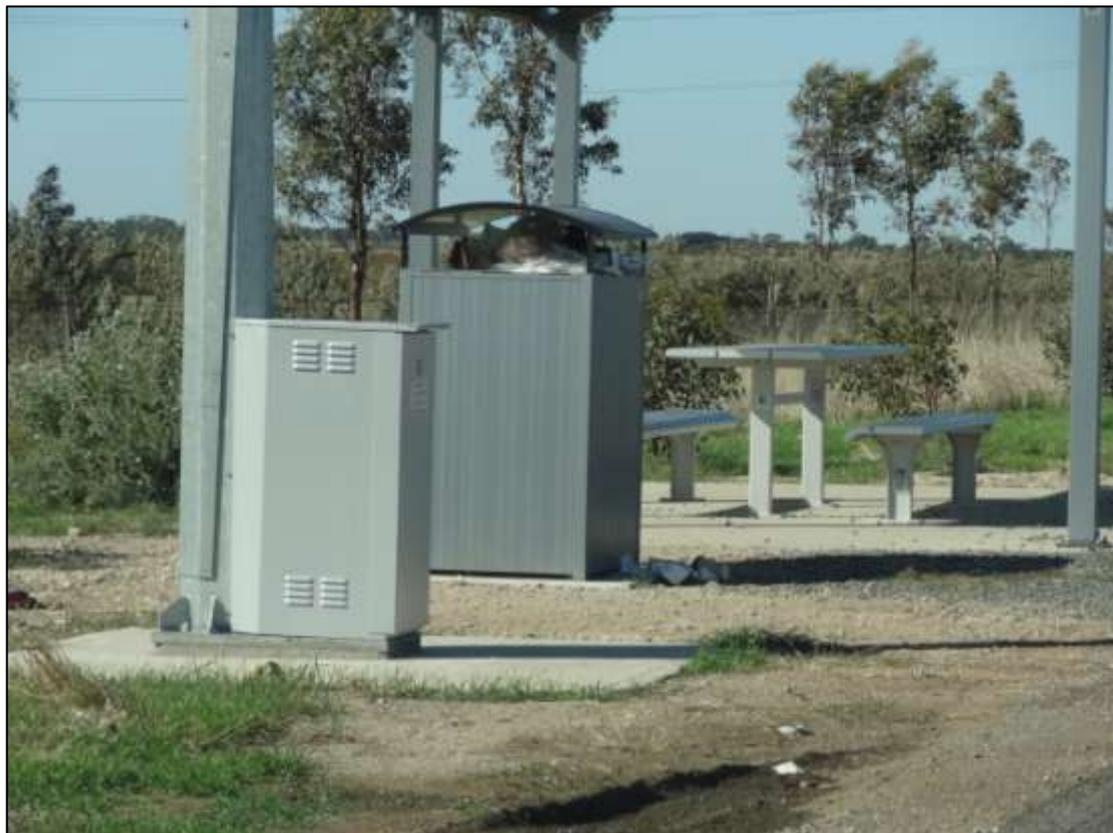
It appears that although many rest stops are provided, they are not being frequently maintained. The first rest area encountered after Taillem Bend in the eastbound direction appeared to be fairly new, however the provided bin was overflowing, indicating that it had not been emptied in some time.

Figure 12 – Overflowing Bin on the Dukes Highway

Improvements to rest areas on the Dukes Highway would involve upgrading facilities and regular maintenance to ensure that they are clean and useable. Upgrades and maintenance will make these rest areas more attractive for drivers, who will therefore be more inclined to stop, helping to reduce driver fatigue.
