RAA Highway Assessment

Highway One

August 2013

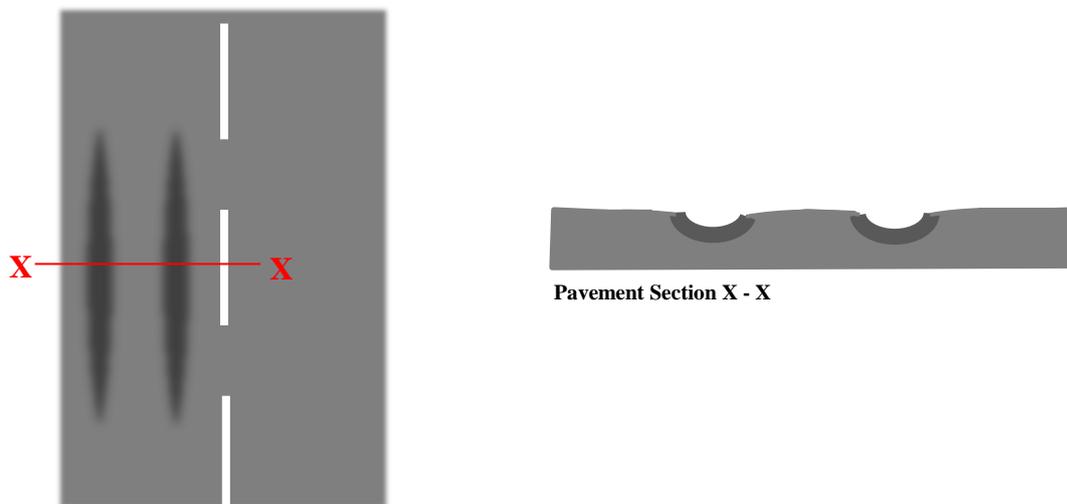
Figure 2 – Pavement Rutting

A rut is a defect in the form of a longitudinal depression in the pavement surface. It usually occurs in the wheel path of vehicles (Figure 2) and is caused by high volumes of heavy vehicles over time. Ruts can also form as a result of environmental influences such as extensive rainfall combined with a poorly sealed surface. This can permit moisture to enter the pavement foundations which can weaken the structure or cause movement in the soil beneath, both of which can lead to rutting.

While rutting can lead to further pavement deterioration, several other problems may also arise as a result. Deep ruts can cause a “guide channel” for wheels and drivers may experience reduced steering performance or having difficulty with trailers tracking the vehicle. Ruts are also prone to filling with water which can increase the potential for aquaplaning, depending on the vehicle speed and depth of the rut. Drivers should always exercise caution when driving in wet weather but particularly on roads that are prone to bad rutting.
