RAA Highway Assessment

Sturt Highway

August 2013

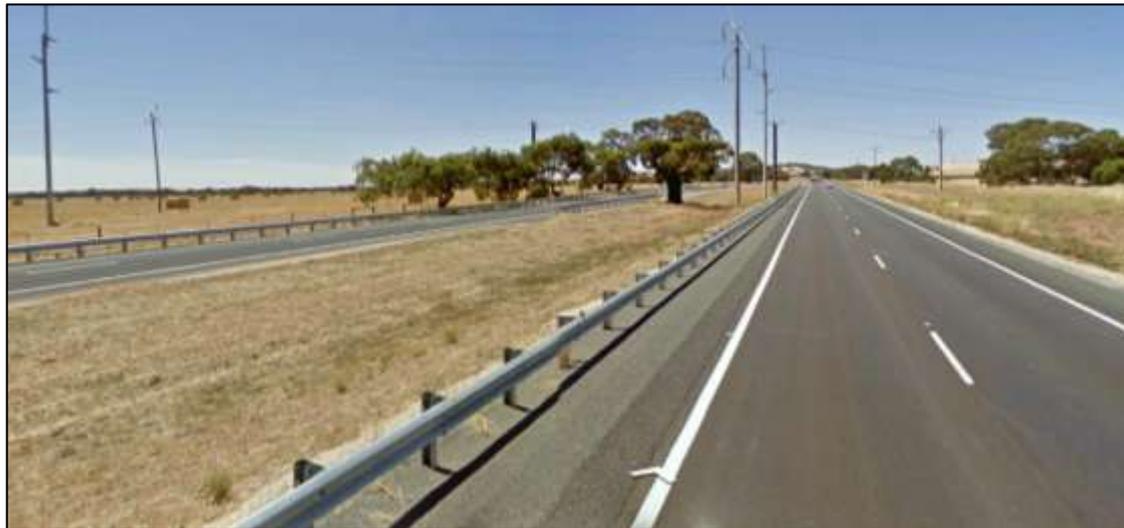
Figure 7 - A duplicated section of the Sturt Highway between Nuriootpa and Gawler (Google Street View 2010)

Currently the section of the Sturt Highway between Gawler and Nuriootpa is duplicated. If traffic volumes continue to increase and head on collisions remain an issue of concern, then further duplication of the highway should be considered.

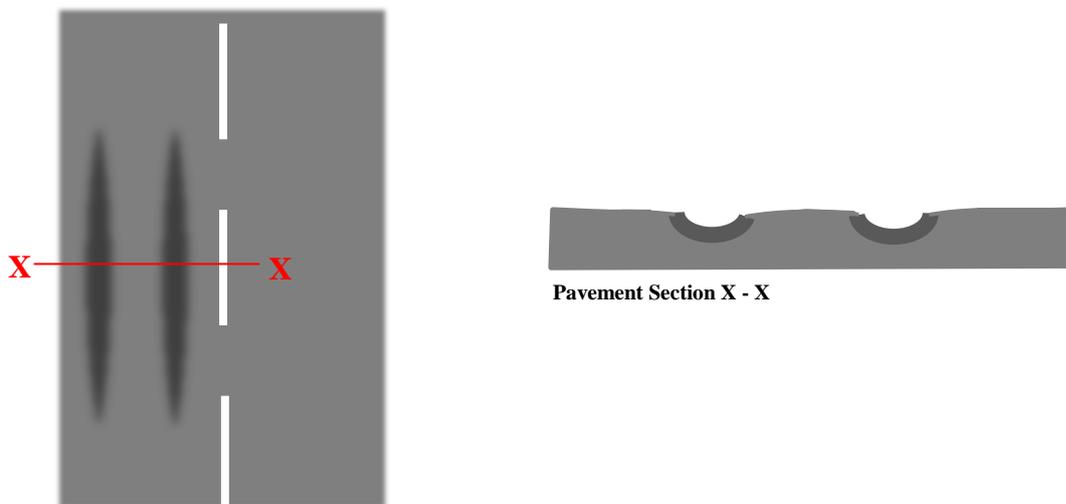
Figure 2 – Pavement Rutting

A rut is a defect in the form of a longitudinal depression in the pavement surface. It usually occurs in the wheel path of vehicles (Figure 2) and is caused by high volumes of heavy vehicles over time. Ruts can also form as a result of environmental influences such as extensive rainfall combined with a poorly sealed surface. This can permit moisture to enter the pavement foundations which can weaken the structure or cause movement in the soil beneath, both of which can lead to rutting.

While rutting can lead to further pavement deterioration, several other problems may also arise as a result. Deep ruts can cause a “guide channel” for wheels and drivers may experience reduced steering performance or having difficulty with trailers tracking the vehicle. Ruts are also prone to filling with water which can increase the potential for aquaplaning, depending on the vehicle speed and depth of the rut. Drivers should always exercise caution when driving in wet weather but particularly on roads that are prone to bad rutting.
