RAA Regional Roads Assessment

Yorke Peninsula

October 2014

In February 2014, RAA conducted a regional roads assessment of the Yorke Peninsula. This report examines the Peninsula's roads and provides recommendations for consideration by the state government and local road authorities.

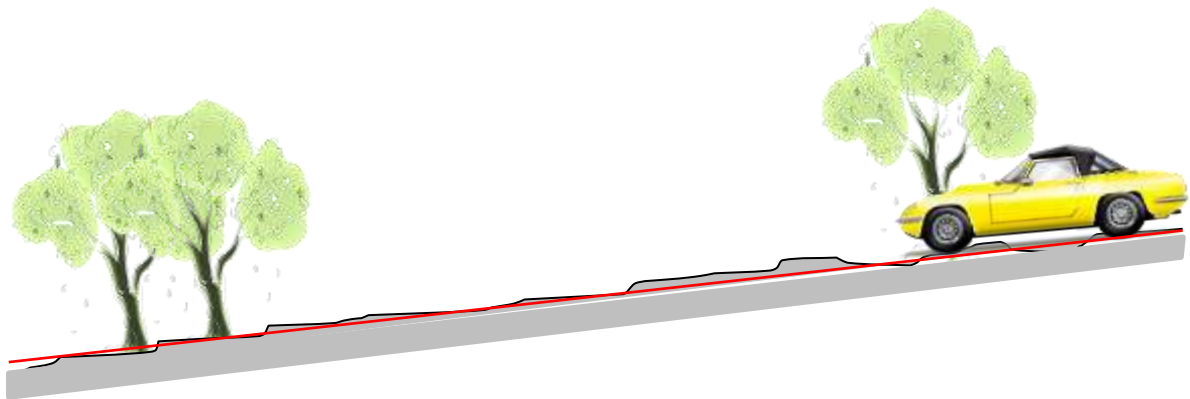
Figure 1 – Longitudinal Road Section

The pavement roughness refers to the irregularities in the road's surface in the direction of travel. These irregularities vary from 0.5 to 50m long and are measured in relation to the intended road surface and recorded in terms of the International Roughness Index (IRI). As the IRI increases, it indicates a rougher pavement surface which will produce an uncomfortable ride for the vehicle's occupants through bumps and undulations. Figure 1 shows the longitudinal profile of a road with an exaggerated surface. The red line indicates the intended surface level and the difference between the lines is the measured roughness.

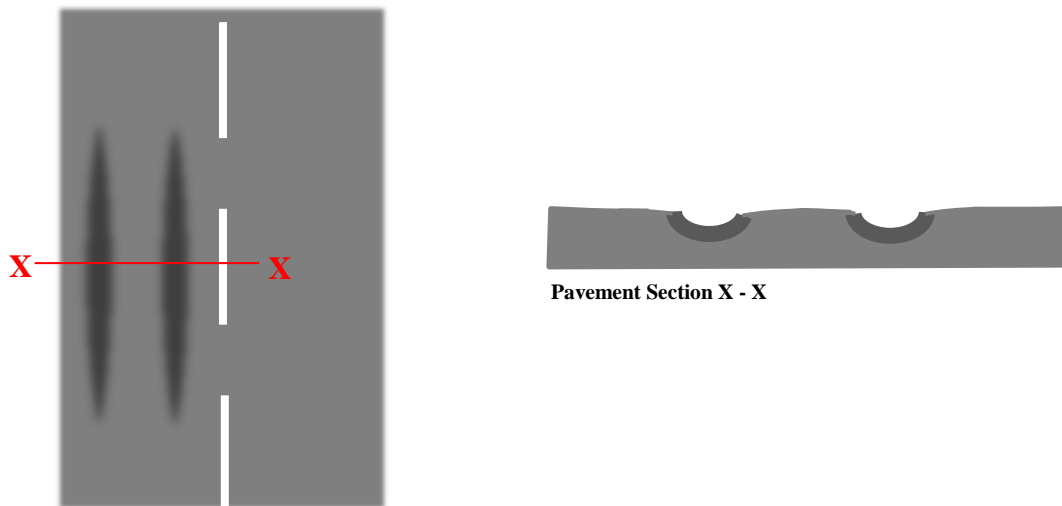
Figure 2 – Pavement Rutting

A rut is a defect in the form of a longitudinal depression in the pavement surface. It usually occurs in the wheel path of vehicles (Figure 2) and is caused by high volumes of heavy vehicles over time. Ruts can also form as a result of environmental influences such as extensive rainfall combined with a poorly sealed surface. This can permit moisture to enter the pavement foundations which can weaken the structure or cause movement in the soil beneath, both of which can lead to rutting.

While rutting can lead to further pavement deterioration, several other problems may also arise as a result. Deep ruts can cause a “guide channel” for wheels and drivers may experience reduced steering performance or have difficulty with trailers tracking the vehicle. Ruts are also prone to filling with water which can increase the potential for aquaplaning, depending on the vehicle speed and depth of the rut. Drivers should always exercise caution when driving in wet weather but particularly on roads that are prone to bad rutting.

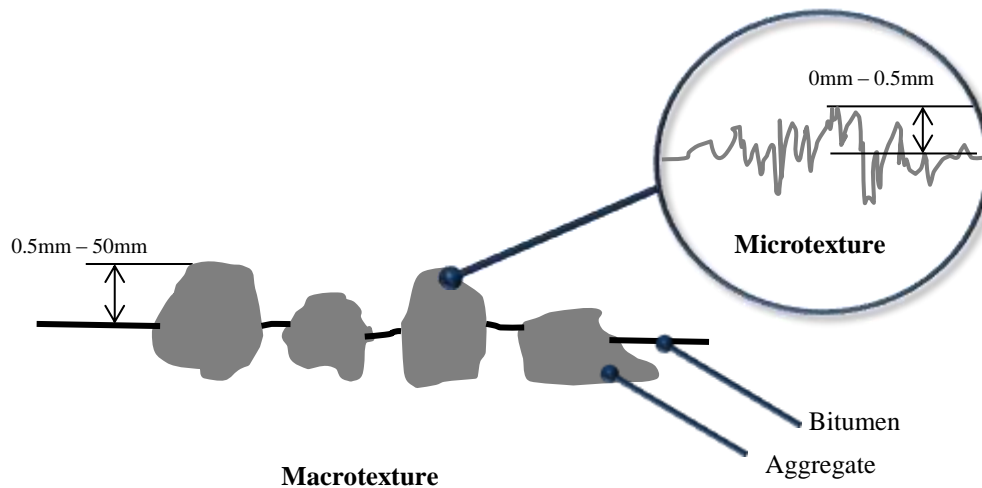
Figure 3 – Pavement Texture

There are two forms of texture within the road surface, the microtexture and macrotexture. The microtexture is created by the rough surface of the aggregate in the surface of the road and contributes to the friction that ensures the vehicle maintains contact with the road and provides good braking performance. The macrotexture is formed from the grooves created in the road surface by the different heights and shape of the aggregate and is important to ensure that rainwater drains away from the tyre, reducing the potential for aquaplaning.

The pavement texture is important to ensure safety for motorists as it provides friction between the contact area of the tyre and the pavement surface. If there is insufficient friction between the tyre and surface, the braking distance will be significantly reduced and if the vehicle speed is too high, there may be a loss of control on curves and bends resulting in collisions with roadside objects.
